Manhole Inspection Summary

Manhole # S09Y__005MH

Insp Date: **4/22/08 1:42 PM**

Location Address: **1229 Pine Heights**

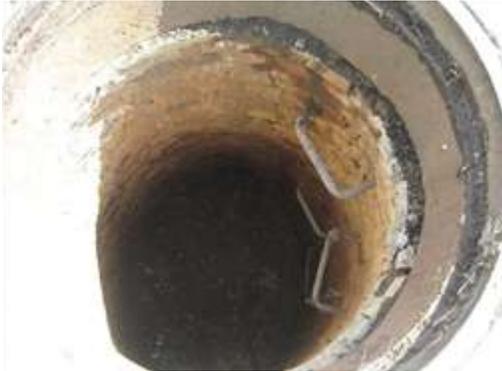
Defect 5

Steps Count: **4** Missing: **0** **Corroded**

corroded steps

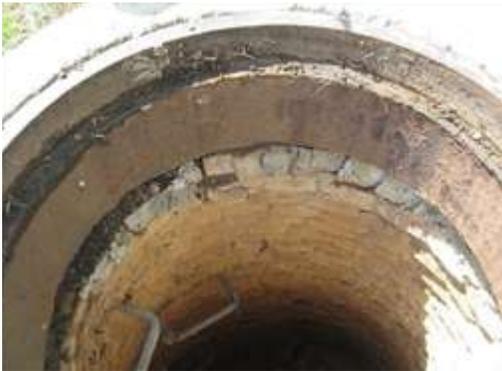
Defect 4

Comments **missing brick at chimney infiltration from chimney do to missing brick and mortar**

Infiltration: None **Joint** Cracks **Mortar** Roots Wall

missing mortar as well as a brick signs of infiltration

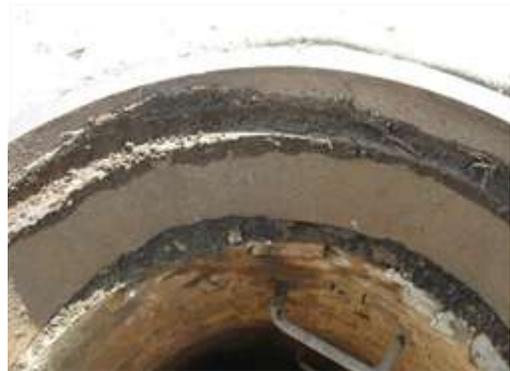
Defect 3

Frame Offset: **1** (in.) Condition: Sound Cracked **Leaks**

offset frame 1"; signs of infiltration

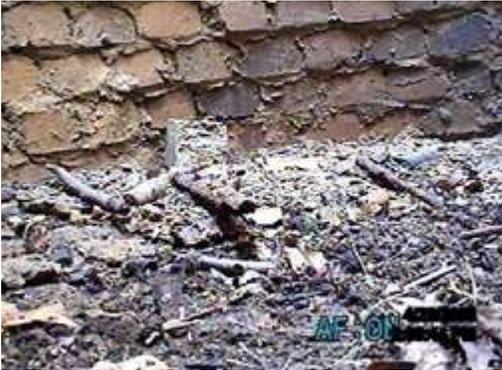
Defect 1

Condition: Sound Cracked Root Intrusion Deteriorated Leaks **Debris**

debris on base

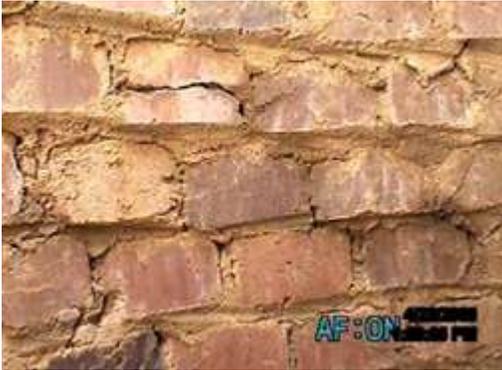
Defect 2

Condition: Sound Cracked Root Intrusion Loose Brick **Deteriorated**

cracked brick in corbel/ no sign of infiltration at sight
